BNL Update 11/8/2016

Injection Molded Lightguides Q/A

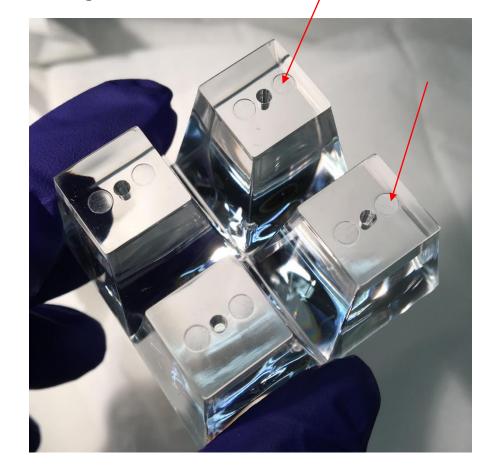
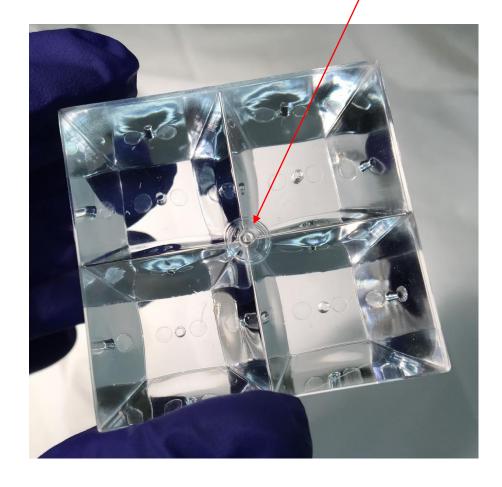
Markings from mold:

Top: ejection marks

bottom: gate (fill point) mark

Both of these will be machined away when the parallel surfaces are machined and polished.

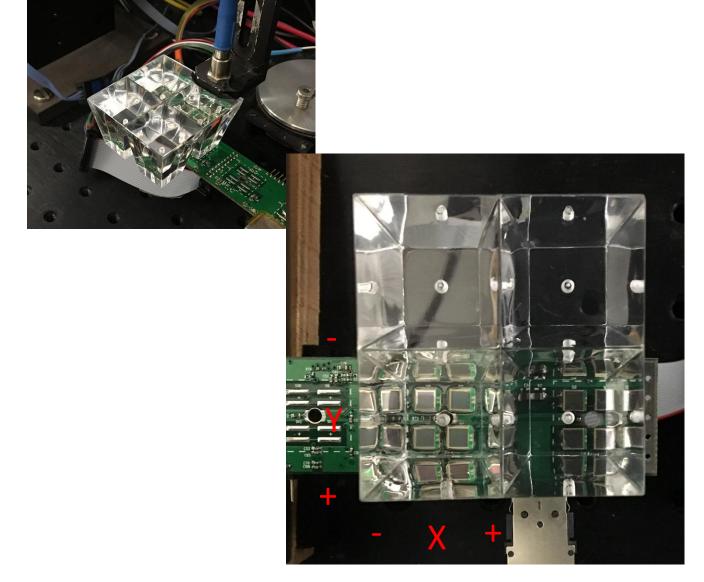
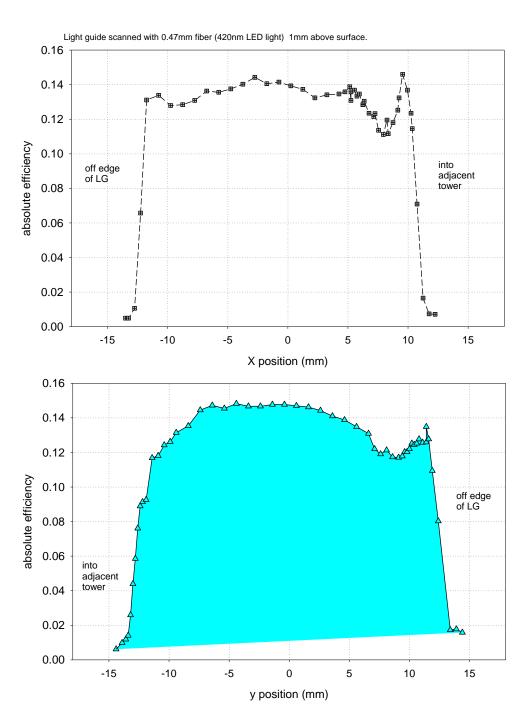
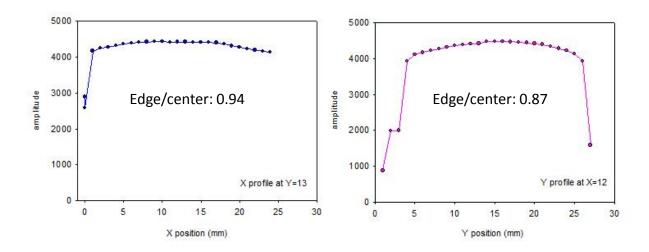
Uniformity scan of injection molded light guide Read out with 4 sipms / rtv coupling

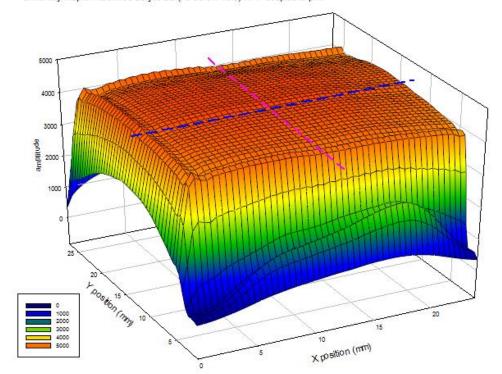
uniformity map of machined acrylic LG (no screw hole) RTV-coupled to pmt
